HOCKANUM RIVER BASIN  
MANCHESTER, CONNECTICUT

CASE POND UPPER DAM  
CT 00560

PHASE I INSPECTION REPORT  
NATIONAL DAM INSPECTION PROGRAM

MAY 1980

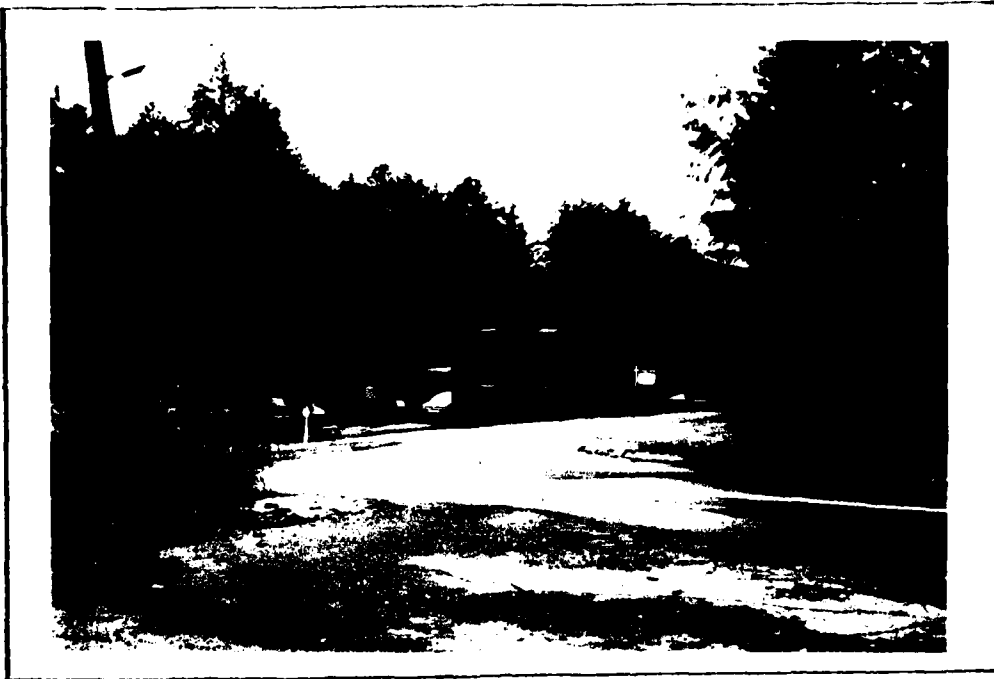
12. REGION TO THE RIGHT OF THE CASE POND LOWER DAM WHERE DISCHARGE WOULD BE CONCENTRATED DURING PERIODS OF EXCESSIVE FLOW. (11/14/79)
